Flood Control Project Maintenance
2020 Structure Summary Report
Overall Unit and Item Ratings

Plumas County

North Fork Feather River Diversion Channel Drop Structure No. 1

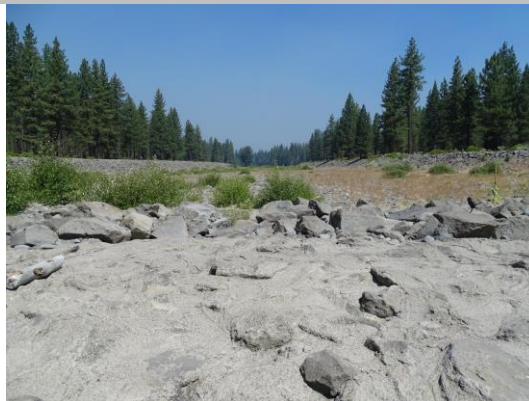
Photo 1 of 2 : ST_2020_NA0015_57_23_20200727_00005.jpg

LM Start	0.00	Rating **	N	Issue No.	23
LM End	0.00	Issue Type +	Ma	Location *	
Category	Structures & Concrete Lined Channels			GPS Latitude/Longitude	
				Start	End
Item	Photo Documentation			40.299243 °	40.299243 °
				-121.262034 °	-121.262034 °
DWR ID	DWR_NA0015_57_t_2012_23				
Action/Comments					
Inspector Comments: The structure and channel are in good condition, clear of debris and flows are not impeded, 2020.

View looking upstream from Drop Structure 1, 2020.

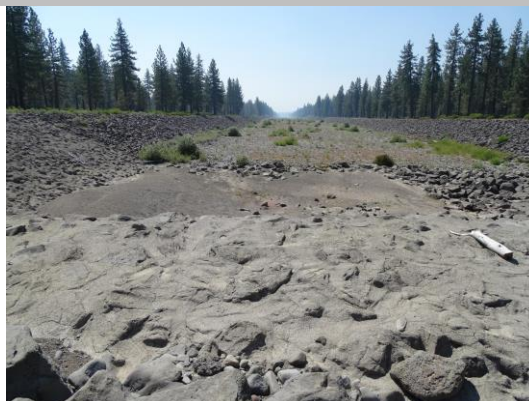
Photo 2 of 2 : ST_2020_NA0015_57_23_20200727_00006.jpg

View looking downstream from Drop Structure 1, 2020.

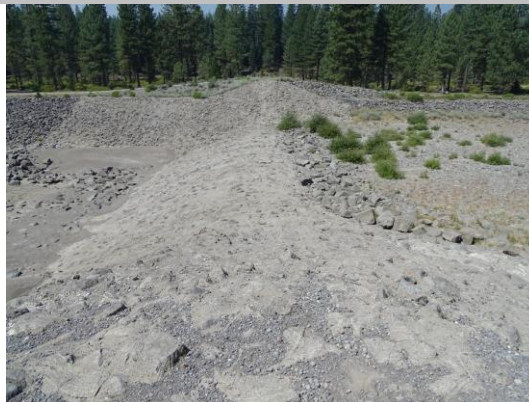
Photo 1 of 1 : ST_2020_NA0015_57_4_20200727_00004.jpg

LM Start	0.00	Rating **	A	Issue No.	4
LM End	0.00	Issue Type +	Ma	Location *	
Category	Structures & Concrete Lined Channels			GPS Latitude/Longitude	
				Start	End
Item	Revetments			40.299243 °	40.299243 °
				-121.262034 °	-121.262034 °
DWR ID	DWR_NA0015_57_t_2012_4				
Action/Comments					
Inspector Comments: Existing riprap protection is properly maintained.

View looking across the drop structure from the left bank at the well maintained concreted revetment, 2020.

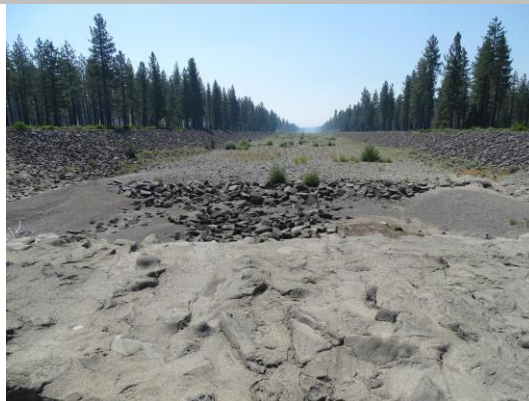
Photo 1 of 2 : ST_2020_NA0015_58_23_20200728_00008.jpg

LM Start	0.00	Rating **	N	Issue No.	23
LM End	0.00	Issue Type +	Ma	Location *	
Category	Structures & Concrete Lined Channels			GPS Latitude/Longitude	
				Start	End
Item	Photo Documentation			40.294270 °	40.294270 °
				-121.258935 °	-121.258935 °
DWR ID	DWR_NA0015_58_t_2012_23				
Action/Comments					
Inspector Comments: The structure and channel are in good condition, clear of debris, and the flows are not impeded, 2020.

View of Drop Structure 2 looking downstream, 2020.

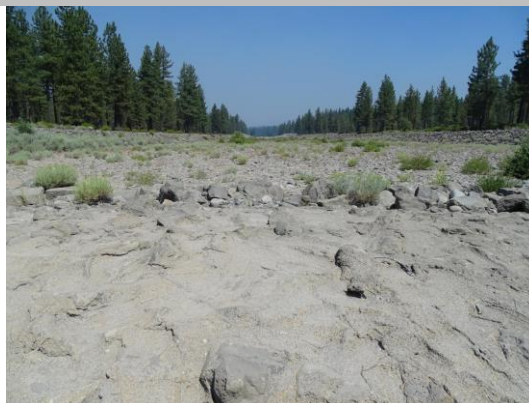
Photo 2 of 2 : ST_2020_NA0015_58_23_20200728_00007.jpg

View of Drop Structure 2 looking upstream, 2020.

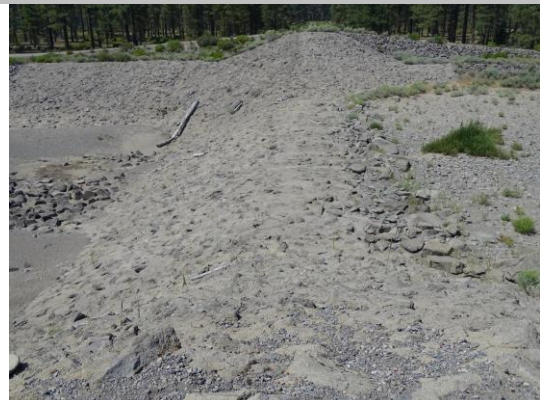
Photo 1 of 1 : ST_2020_NA0015_58_4_20200728_00005.jpg

LM Start	0.00	Rating **	A	Issue No.	4
LM End	0.00	Issue Type +	Ma	Location *	
Category	Structures & Concrete Lined Channels			GPS Latitude/Longitude	
				Start	End
Item	Revetments			40.294270 °	40.294270 °
				-121.258935 °	-121.258935 °
DWR ID	DWR_NA0015_58_t_2012_4				
Action/Comments					
Inspector Comments: Existing concreted revetment protection is properly maintained.

View looking across the drop structure from the left bank at the well maintained concreted revetment, 2020.

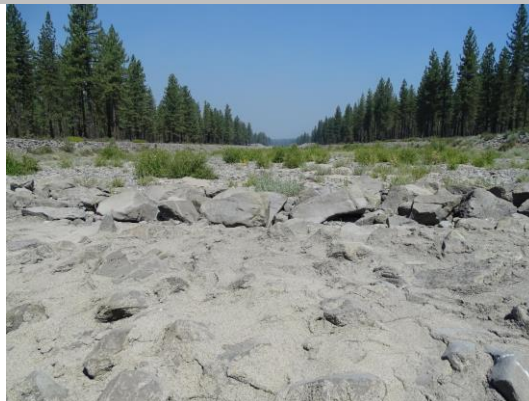
Photo 1 of 2 : ST_2020_NA0015_59_23_20200728_00005.jpg

LM Start	0.00	Rating **	N	Issue No.	23
LM End		Issue Type +	Ma	Location *	
Category	Structures & Concrete Lined Channels			GPS Latitude/Longitude	
				Start	End
Item	Photo Documentation			40.289767 °	40.289767 °
				-121.256375 °	-121.256375 °
DWR ID	DWR_NA0015_59_t_2012_23				
Action/Comments					
Inspector Comments: The structure and channel are in good condition, clear of debris, and the flows are not impeded, 2020.

View looking upstream at Drop Structure 3, 2020.

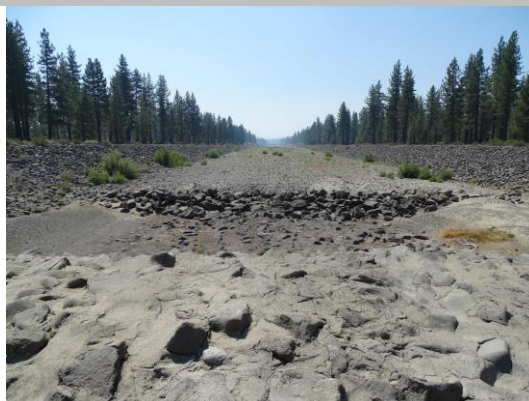
Photo 2 of 2 : ST_2020_NA0015_59_23_20200728_00006.jpg

View looking downstream at Drop Structure 3, 2020.

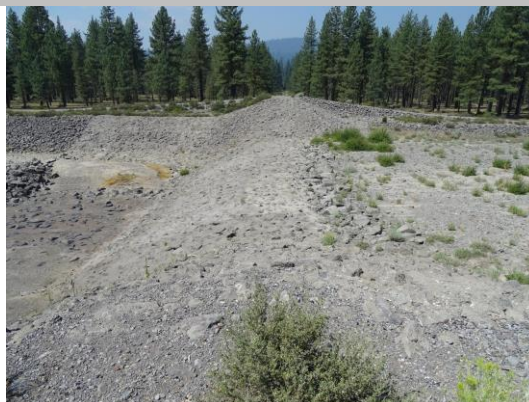
Photo 1 of 1 : ST_2020_NA0015_59_4_20200728_00004.jpg

LM Start	0.00	Rating **	A	Issue No.	4
LM End	0.00	Issue Type +	Ma	Location *	
Category	Structures & Concrete Lined Channels			GPS Latitude/Longitude	
				Start	End
Item	Revetments			40.289767 °	40.289767 °
				-121.256375 °	-121.256375 °
DWR ID	DWR_NA0015_59_t_2012_4				
Action/Comments					
Inspector Comments: Existing concrete riprap protection is properly maintained, 2020.

View looking across the drop structure from the left bank at the well maintained concreted revetment, 2020.

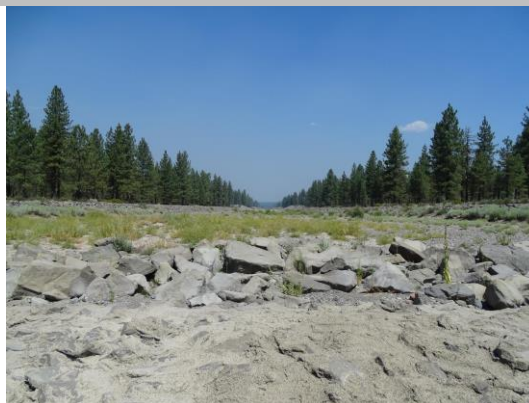
Photo 1 of 2 : ST_2020_NA0015_60_23_20200728_00006.jpg

LM Start	0.00	Rating **	N	Issue No.	23
LM End	0.00	Issue Type +	Ma	Location *	
Category	Structures & Concrete Lined Channels			GPS Latitude/Longitude	
				Start	End
Item	Photo Documentation			40.285653 °	40.285653 °
				-121.253902 °	-121.253902 °
DWR ID	DWR_NA0015_60_t_2012_23				
Action/Comments					
Inspector Comments: The structure and channel are in good condition, clear of debris, and the flows are not impeded, 2020.

View looking upstream at Drop Structure 4, 2020.

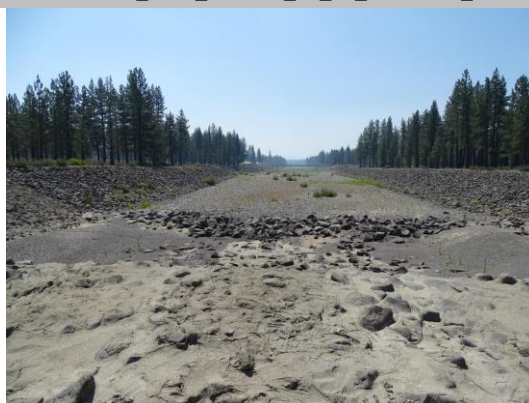
Photo 2 of 2 : ST_2020_NA0015_60_23_20200728_00007.jpg

View looking downstream at Drop Structure 4, 2020.

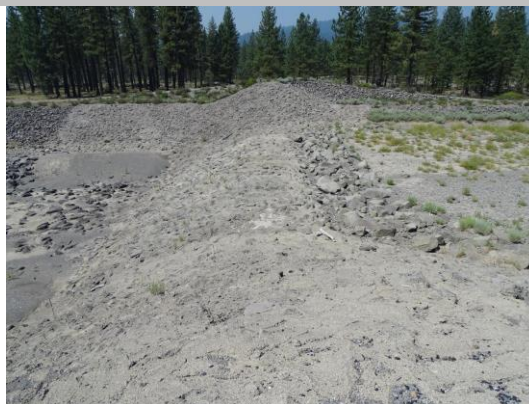
Photo 1 of 1 : ST_2020_NA0015_60_4_20200728_00005.jpg

LM Start	0.00	Rating **	A	Issue No.	4
LM End	0.00	Issue Type +	Ma	Location *	
Category	Structures & Concrete Lined Channels			GPS Latitude/Longitude	
				Start	End
Item	Revetments			40.285653 °	40.285653 °
				-121.253902 °	-121.253902 °
DWR ID	DWR_NA0015_60_t_2012_4				
Action/Comments					
Inspector Comments: Existing concreted riprap protection is properly maintained.

View looking across the drop structure from the left bank at the well maintained concreted revetment, 2020.

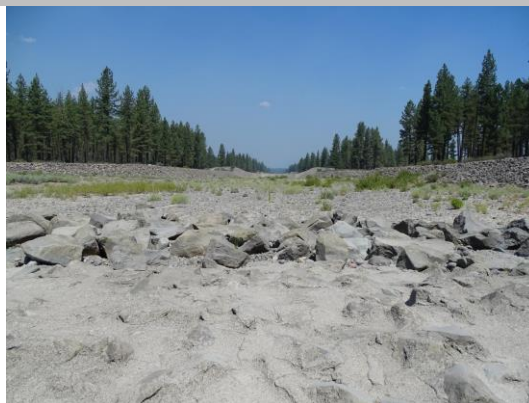
Photo 1 of 2 : ST_2020_NA0015_61_23_20200728_00005.jpg

LM Start	0.00	Rating **	N	Issue No.	23
LM End	0.00	Issue Type +	Ma	Location *	
Category	Structures & Concrete Lined Channels			GPS Latitude/Longitude	
				Start	End
Item	Photo Documentation			40.283028 °	40.283028 °
				-121.252348 °	-121.252348 °
DWR ID	DWR_NA0015_61_t_2012_23				
Action/Comments					
Inspector Comments: The structure and channel are in good condition, clear of debris, and the flows are not impeded, 2020.

View looking upstream at Drop Structure 5, 2020.

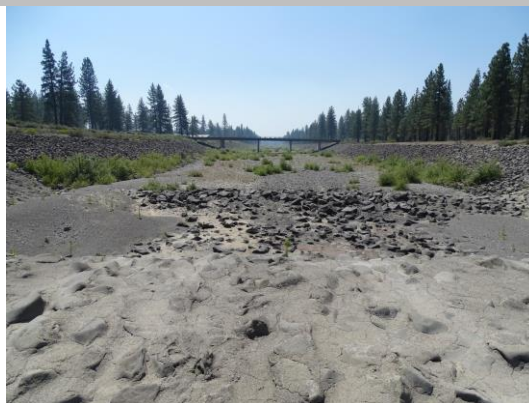
Photo 2 of 2 : ST_2020_NA0015_61_23_20200728_00006.jpg

View looking downstream at Drop Structure 5, 2020.

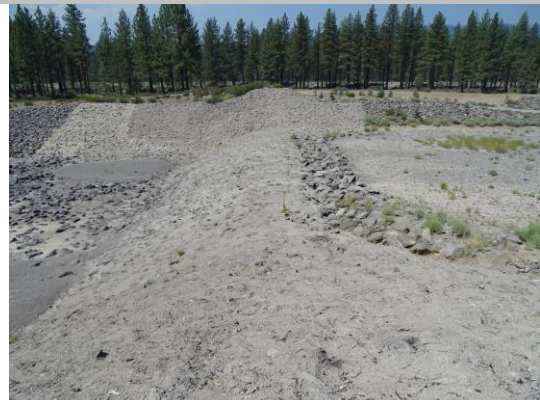
Photo 1 of 1 : ST_2020_NA0015_61_4_20200728_00004.jpg

LM Start	0.00	Rating **	A	Issue No.	4
LM End	0.00	Issue Type +	Ma	Location *	
Category	Structures & Concrete Lined Channels			GPS Latitude/Longitude	
				Start	End
Item	Revetments			40.283028 °	40.283028 °
				-121.252348 °	-121.252348 °
DWR ID	DWR_NA0015_61_t_2012_4				
Action/Comments					
Inspector Comments: Existing concreted riprap protection is properly maintained.

View looking across the drop structure from the left bank at the well maintained concreted revetment, 2020

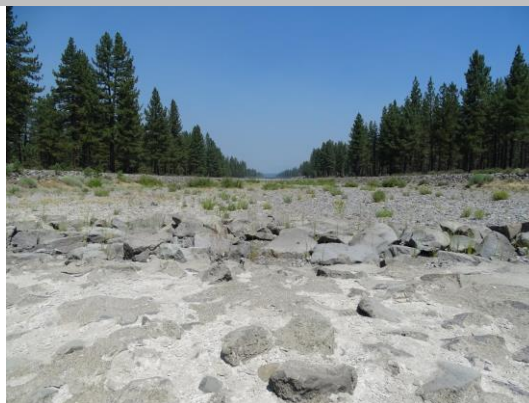
Photo 1 of 2 : ST_2020_NA0015_62_23_20200728_00005.jpg

LM Start	0.00	Rating **	N	Issue No.	23
LM End	0.00	Issue Type +	Ma	Location *	
Category	Structures & Concrete Lined Channels			GPS Latitude/Longitude	
				Start	End
Item	Photo Documentation			40.275902 °	40.275902 °
				-121.248142 °	-121.248142 °
DWR ID	DWR_NA0015_62_t_2012_23				
Action/Comments					
Inspector Comments: The structure and channel are in good condition, clear of debris, and the flows are not impeded, 2020.

View looking upstream at Drop Structure 6, 2020.

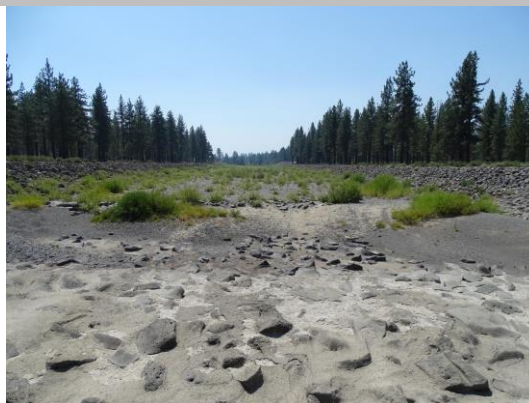
Photo 2 of 2 : ST_2020_NA0015_62_23_20200728_00006.jpg

View looking downstream at Drop Structure 6, 2020.

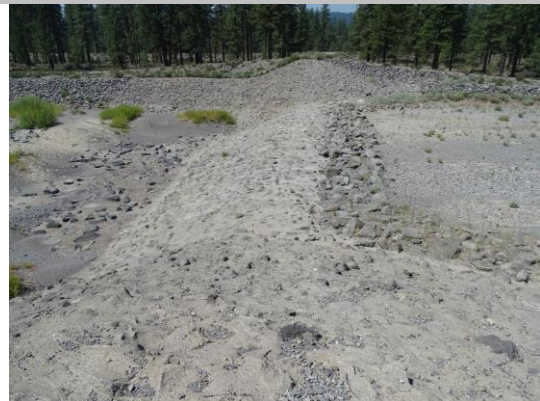
Photo 1 of 1 : ST_2020_NA0015_62_4_20200728_00007.jpg

LM Start	0.00	Rating **	A	Issue No.	4
LM End	0.00	Issue Type +	Ma	Location *	
Category	Structures & Concrete Lined Channels			GPS Latitude/Longitude	
				Start	End
Item	Revetments			40.275902 °	40.275902 °
				-121.248142 °	-121.248142 °
DWR ID	DWR_NA0015_62_t_2012_4				
Action/Comments					
Inspector Comments: Existing concrete riprap protection is properly maintained.

View looking across the drop structure from the left bank at the well maintained concreted revetment, 2020.

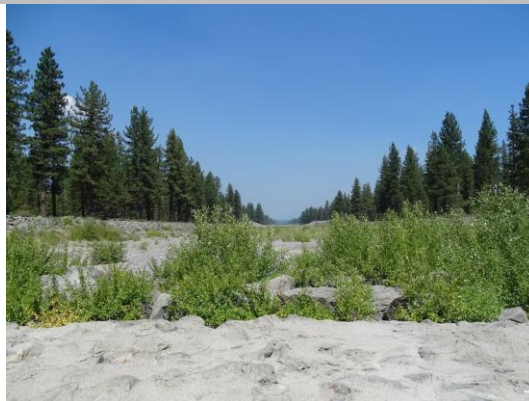
Photo 1 of 2 : ST_2020_NA0015_63_23_20200728_00005.jpg

LM Start	0.00	Rating **	N	Issue No.	23
LM End	0.00	Issue Type +	Ma	Location *	
Category	Structures & Concrete Lined Channels			GPS Latitude/Longitude	
				Start	End
Item	Photo Documentation			40.272544 °	40.272544 °
				-121.246161 °	-121.246161 °
DWR ID	DWR_NA0015_63_t_2015_23				
Action/Comments					
Inspector Comments: The structure and channel are in good condition, clear of debris, and the flows are not impeded, 2020.

View looking upstream at Drop Structure 7, 2020.

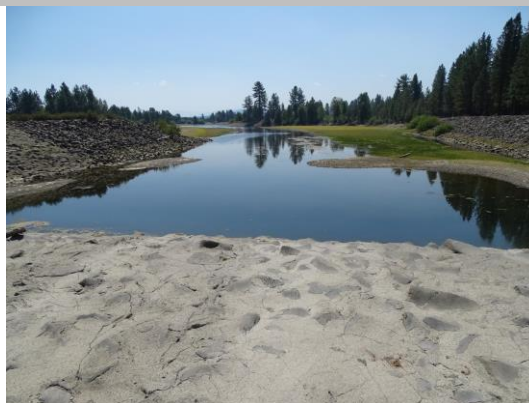
Photo 2 of 2 : ST_2020_NA0015_63_23_20200728_00006.jpg

View looking downstream at Drop Structure 7, 2020.

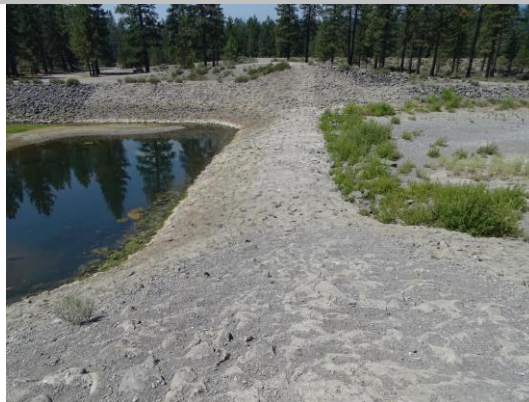
Photo 1 of 1 : ST_2020_NA0015_63_4_20200728_00007.jpg

LM Start	0.00	Rating **	A	Issue No.	4	
LM End	0.00	Issue Type +	Ma	Location *		
Category	Structures & Concrete Lined Channels			GPS Latitude/Longitude		
				Start		End
Item	Revetments			40.272544 °		40.272544 °
				-121.246161 °		-121.246161 °
DWR ID	DWR_NA0015_63_t_2012_4					
Action/Comments						
Inspector Comments: Existing concrete riprap protection is properly maintained.

View looking across the drop structure from the left bank at the well maintained concreted revetment, 2020.

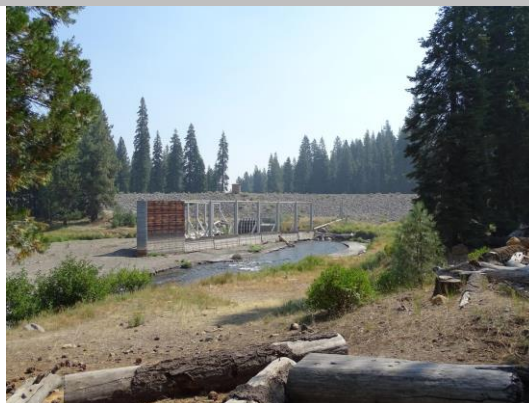
Photo 1 of 3 : ST_2020_NA0015_37_23_20200728_00025.jpg

View of the inflow structure from the top of the dam, 2020.

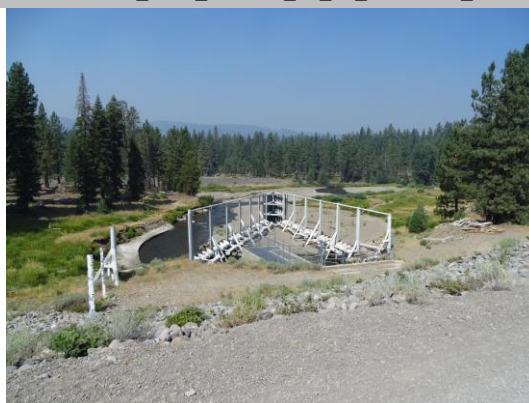
Photo 2 of 3 : ST_2020_NA0015_37_23_20200728_00026.jpg

View of the inflow structure from the top of the dam, 2020.

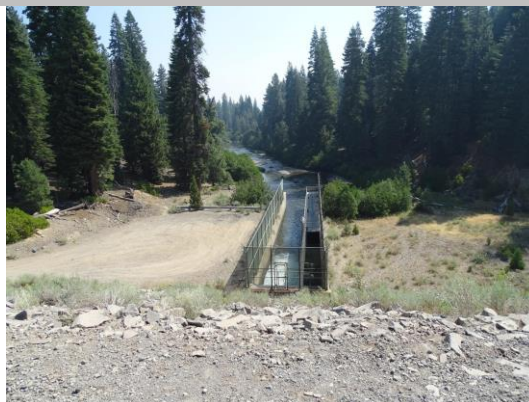
Photo 3 of 3 : ST_2020_NA0015_37_23_20200728_00027.jpg

View of the outfall structure from the top of the dam, 2020.

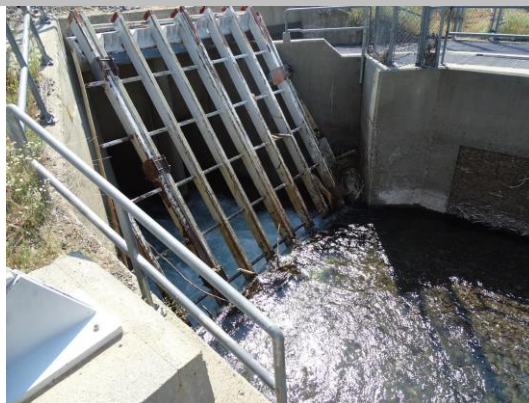
Photo 1 of 1 : ST_2020_NA0015_37_9_20200728_00031.jpg

LM Start	0.00	Rating **	A	Issue No.	9	
LM End	0.00	Issue Type +	Ma	Location *		
Category	Structures & Concrete Lined Channels			GPS Latitude/Longitude		
				Start		End
Item	Trash Racks			40.302834 °		40.302834 °
				-121.261901 °		-121.261901 °
DWR ID	DWR_NA0015_37_t_2012_9					
Action/Comments						
Inspector Comments: Trash rack is well maintained, 2020.

View of the trash rack, 2020.

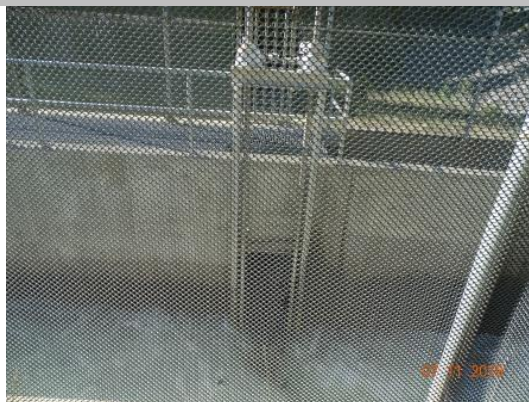
Photo 1 of 2 : ST_2020_NA0015_37_11_20200727_00007.jpg

LM Start	0.00	Rating **	A	Issue No.	11	
LM End	0.00	Issue Type +	Ma	Location *		
Category	Structures & Concrete Lined Channels			GPS Latitude/Longitude		
				Start		End
Item	Sluice/Slide Gates			40.302834 °		40.302834 °
				-121.261901 °		-121.261901 °
DWR ID	DWR_NA0015_37_t_2012_11					
Action/Comments						
Inspector Comments: Slide gates are in good working condition, 2020.

View looking through the fence at the fish ladder slide gate, 2019.

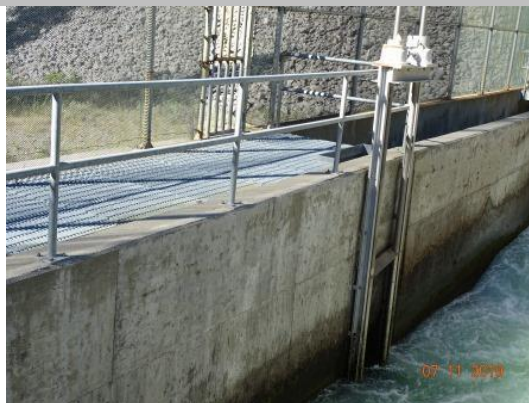
Photo 2 of 2 : ST_2020_NA0015_37_11_20200727_00008.jpg

LM Start	0.00	Rating **	A	Issue No.	11 (cont)	
LM End	0.00	Issue Type +	Ma	Location *		
Category	Structures & Concrete Lined Channels			GPS Latitude/Longitude		
				Start		End
Item	Sluice/Slide Gates			40.302834 °	40.302834 °	
				-121.261901 °	-121.261901 °	
DWR ID	DWR_NA0015_37_t_2012_11					
Action/Comments						
Inspector Comments: Slide gates are in good working condition, 2020.

View looking at the fish ladder slide gate, 2019.

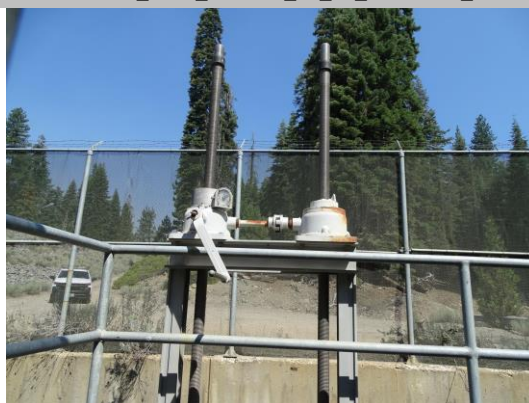
Photo 1 of 1 : ST_2020_NA0015_37_13_20200804_00037.jpg

LM Start	0.00	Rating **	A	Issue No.	13
LM End	0.00	Issue Type +	Ma	Location *	
Category	Structures & Concrete Lined Channels			GPS Latitude/Longitude	
				Start	End
Item	Manual Gate Operators			40.302834 °	40.302834 °
				-121.261901 °	-121.261901 °
DWR ID	DWR_NA0015_37_t_2012_13				
Action/Comments					
Inspector Comments: Manual gate operator appears to be working as intended, fittings have been greased and the LMA was there to show the operation of them in 2018.

View of the manual screw gates for the fish ladder slide gate on the outfall structure, 2020.

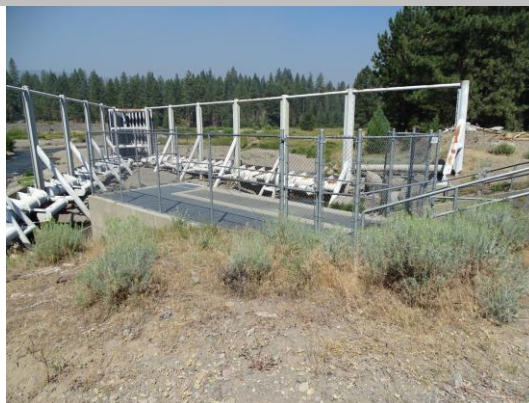
Photo 1 of 2 : ST_2020_NA0015_37_17_20200728_00035.jpg

LM Start	0.00	Rating **	A	Issue No.	17
LM End	0.00	Issue Type +	Ma	Location *	
Category	Structures & Concrete Lined Channels			GPS Latitude/Longitude	
				Start	End
Item	Security Fencing			40.302834 °	40.302834 °
				-121.261901 °	-121.261901 °
DWR ID	DWR_NA0015_37_t_2012_17				
Action/Comments					
Inspector Comments: Safety / security fence is in good condition around the inlet and fish ladder and also around the outfall structure and the fish ladder outfall, 2020.

View of the security fencing around the fish ladder, 2020.

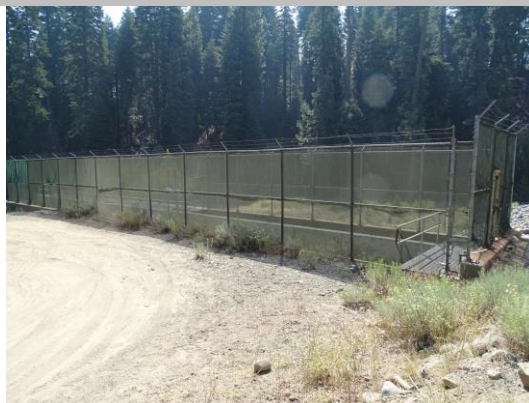
Photo 2 of 2 : ST_2020_NA0015_37_17_20200728_00036.jpg

View of the security fencing around the outfall, 2020.

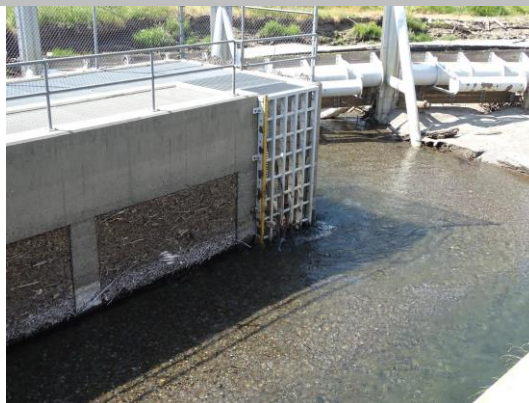
Photo 1 of 2 : ST_2020_NA0015_37_18_20200804_00039.jpg

LM Start	0.00	Rating **	A	Issue No.	18
LM End	0.00	Issue Type +	Ma	Location *	
Category	Structures & Concrete Lined Channels			GPS Latitude/Longitude	
				Start	End
Item	Closure Structures			40.302834 °	40.302834 °
				-121.261901 °	-121.261901 °
DWR ID	DWR_NA0015_37_t_2012_18				
Action/Comments					
Inspector Comments: It appears the closure structure is in good condition. Make sure the flash board drop structures properly seal the front of the structure each year, 2020.

View of the inside of the debris protection closures at the structure inlet, 2020.

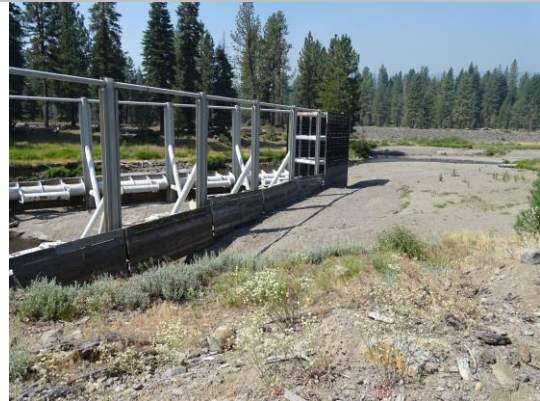
Photo 2 of 2 : ST_2020_NA0015_37_18_20200804_00040.jpg

LM Start	0.00	Rating **	A	Issue No.	18 (cont)
LM End	0.00	Issue Type +	Ma	Location *	
Category	Structures & Concrete Lined Channels	GPS Latitude/Longitude			
		Start		End	
Item	Closure Structures	40.302834 °		40.302834 °	
		-121.261901 °		-121.261901 °	
DWR ID	DWR_NA0015_37_t_2012_18				
Action/Comments					
Inspector Comments: It appears the closure structure is in good condition. Make sure the flash board drop structures properly seal the front of the structure each year, 2020.

View of the outside of the debris protection closures at the structure inlet, 2020.

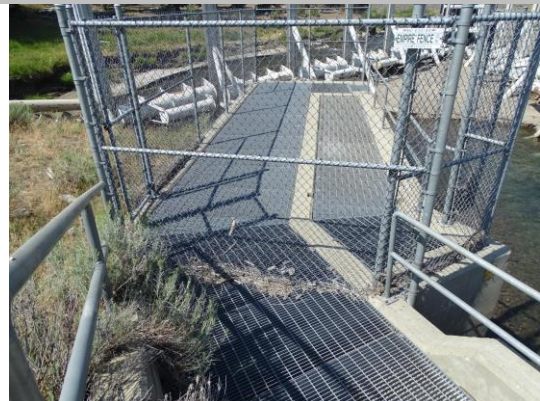
Photo 1 of 1 : ST_2020_NA0015_37_20_20200728_00032.jpg

LM Start	0.00	Rating **	A	Issue No.	20
LM End	0.00	Issue Type +	Ma	Location *	
Category	Structures & Concrete Lined Channels	GPS Latitude/Longitude			
		Start		End	
Item	Other Metallic Items	40.302834 °		40.302834 °	
		-121.261901 °		-121.261901 °	
DWR ID	DWR_NA0015_37_t_2012_20				
Action/Comments					
Inspector Comments: All the metal decks are in good condition, 2020.

View of the metal deck of the fish ladder inlet, 2020.

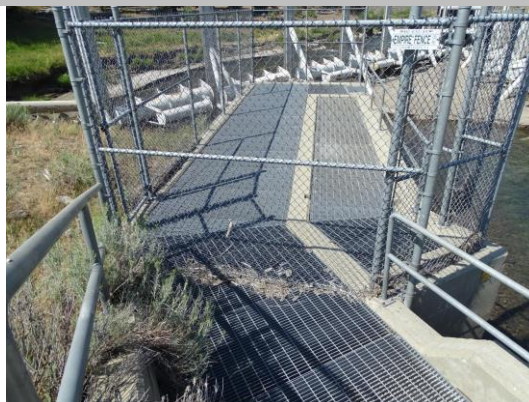
Photo 1 of 2 : ST_2020_NA0015_37_22_20200804_00042.jpg

LM Start	0.00	Rating **	A	Issue No.	22
LM End	0.00	Issue Type +	Ma	Location *	
Category	Structures & Concrete Lined Channels	GPS Latitude/Longitude			
		Start		End	
Item	Safety	40.302834 °		40.302834 °	
		-121.261901 °		-121.261901 °	
DWR ID	DWR_NA0015_37_t_2012_22				
Action/Comments					
Inspector Comments: No safety issues identified at this location. There are hand rails around the inlet and fencing around the fish ladder for safety and fall protection, there is also security fence around the outlet of the structure, 2020.

View of the hand rail around the inlet and fencing around the fish ladder for safety & fall protection, 2020.

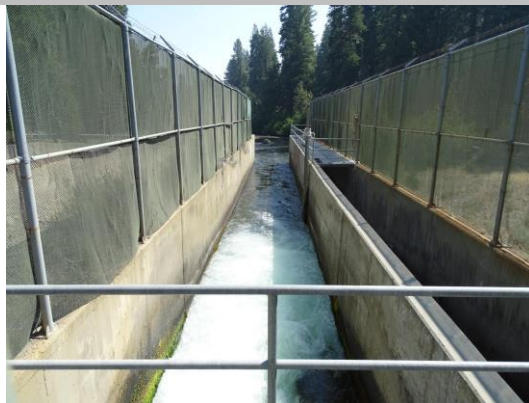
Photo 2 of 2 : ST_2020_NA0015_37_22_20200804_00043.jpg

View of the hand rail around the outlet fish ladder for safety, 2020.
